Technical Report CHL-97-17
August 1997

Periodic Inspection of Humboldt Bay Jetties, Eureka, California

Report 1 Base Conditions

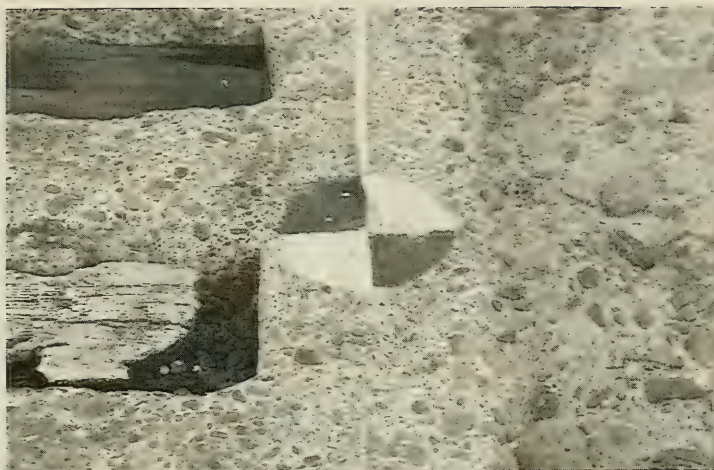
Figure 9. Typical target established on dolosse at Humboldt Bay

In addition, targets were established on selected dolos armor units to serve as control to check the accuracy of the photogrammetric work. Targets were 20.3 cm (8 in.) in diameter and divided into four quadrants, which were painted alternately white and black. A typical target is shown in Figure 9. This style of contrasting target provides a precise center point for which measurements can be made by both land and photogrammetric surveys. A high quality epoxy-based marine paint was used to minimize the need for repainting, and a 0.64-cm (1/4-in.) hole was drilled at the center of each target for identification in subsequent surveys.

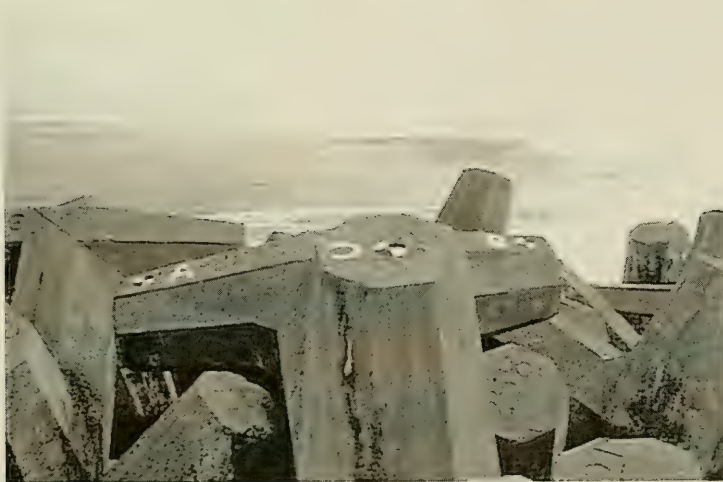
Figure 10. Example of a dolos with three targets established

A total of 34 dolosse on the north jetty and 33 dolosse on the south jetty were selected for targeting. Fifteen dolosse on the north jetty were painted with three targets (dolosse 101 - 115) and nineteen dolosse were painted with a single target (dolosse 1 - 19). On the south jetty, 16 dolosse were painted with three targets (dolosse 201 - 216) and 17 dolosse were painted with a single target (dolosse 51 - 67). An example of a dolos with three targets is shown in Figure 10. Note the targets are labeled A, B, and C. Three targets on individual armor units allow for very precise measurements depicting individual armor unit movement. Armor units selected for targeting were distributed along the length of the jetties on both the sea sides and channel sides of the structures and around the heads. They were also distributed from the crest to the waterline. Figures 11 and 12 show the locations of targeted armor units on the north and south jetties, respectively. Units chosen for targeting had flat surfaces close to horizontal to maximize their visibility in aerial photography and allow for accurate representation of armor unit movement.
